Cross Sloped Trail and Water Bars

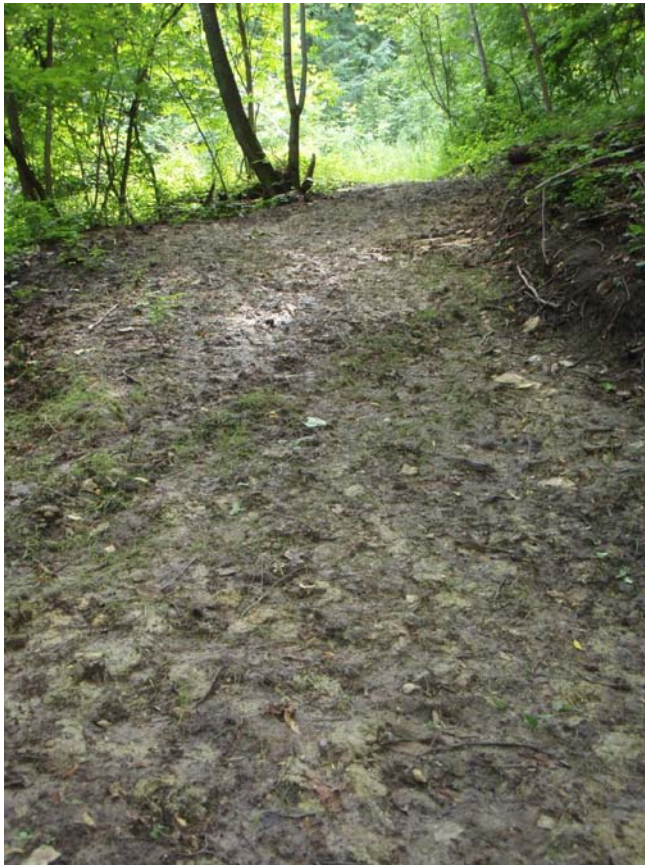
In an effort to minimize erosion on the trail, and to keep the trail as dry as possible, the trail is cross sloped and water bars were dug into the steep parts of the trail. The cross sloping causes the water to run off the side of the trail instead of pooling in the middle as it would if the trail was level. The water bars are channels dug into the trail so water flows off the trail instead of straight down it. The water bars help mitigate erosion by getting water off the un-vegetated trail, and slowing the water down. Ideally, there would be logs set into the channels so the water would not erode the channels, but since the part of the trail with water bars is on the Decorah shale layer, securing logs was not possible. The part of the trail with the water bars is a logging road and after skidding logs on this route, the trail was re-graded to shed water along the entire length rather than let water run in tracks. Water bars with a smooth trench and berm crossing the trail help divert water in heavy runoff events but permit easy passage on foot or by machine.

Water bar on the Lost Creek Hiking Trail
